# TRENCHLESS TECHNOLOGY

Microtunneling Project Team Tackles  
the "Impossible" in Orinda, California

# Heritage Oaks and Harried Commuters Saved in Orinda

The South Orinda Sewer Improvement Microtunneling Project is the Trenchless Technology Project-of-the-Year – New Installation for 1998. Involving 8,250 lf of 36-in. trunk sewer installed in the valley's primary traffic corridor, the South Orinda project demonstrated how the Central Contra Costa Sanitary District (CCCSD) planned and carried out what is believed to be one of the largest microtunneling projects in the San Francisco Bay area. Despite a host of design and construction challenges, the project is successfully moving toward completion by early fall.

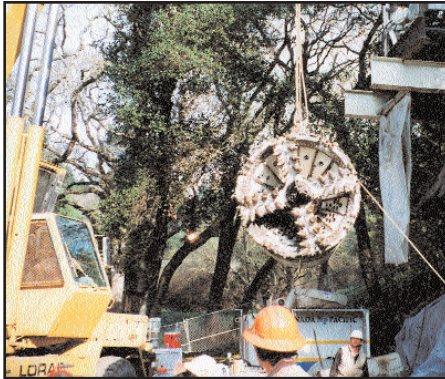
**Top:** Nada Pacific lowers the 44-in. Akkerman microtunneler into a launch pit.

The combination of claystone and siltstone rock formation reared its head quickly in the first launch of the 48-in. Akkerman Microtunnel. The standard cutting head on the microtunneler made slow progress in the mixed conditions, causing the unit to be retracted in the initial drive. Contractor Nada Pacific opted to install a "Christmas Tree" cutting head, which had worked well in conventional tunneling in similar soil conditions. Although this was Nada Pacific's first experience with the Christmas Tree head, the contractor was able to install the head on the bidirectional microtunnel and modify it to counter a tendency to create a roll problem. Production rates in the weak bedrock rose dramatically with the new head, Pilecki reported.

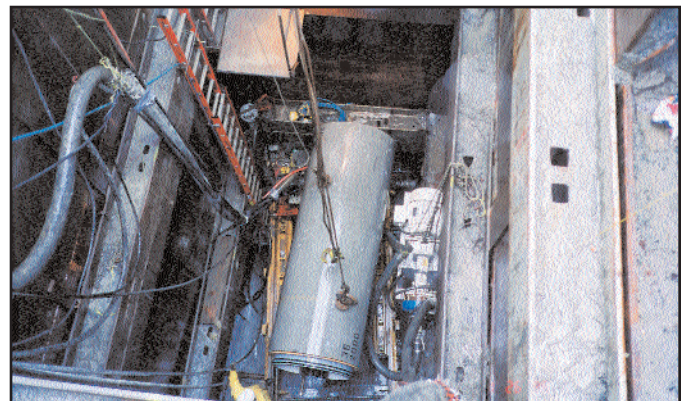
**Right:** A 10-ft section of 36-in. RCP is placed into the jacking frame during heavy El Nino rains.

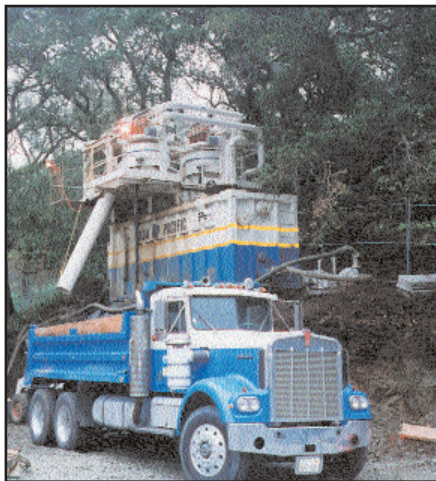
**An Akkerman slurry separation plant is perched in the confined area under a large Heritage Oak.**

Site constraints presented persistent difficulty for the contractor. Most of the bore pits had limited space and poor access. In the space that was available, large trees and other landmarks hampered the construction process. To minimize equipment needs, the contractor chose to go with half the normal tanks

for the separation plant. That raised difficulties in keeping the slurry water density stable and slowed the advance rate. Support trailers and pipe were stored at a staging area away from project sites. Each site required a new scheme for equipment layout, calling
